# Microcontroller Technical Information

ID78K0-QB 78K0 Integrated Debugger  Usage Restrictions	Document No.	ZMT-F35-11-0003	1/1
	Date issued	April 19, 2011	
	Issued by	MCU Tool Product Marketing Department MCU Software Division MCU Business Unit Renesas Electronics Corporation	
Related documents  78K0 Integrated Debugger ID78K0-QB Ver. 3.10 Operating Precautions: U19611EJ1V0UM00	Notification classification	✓ Upgrade Document modification Other notification	Usage restriction

Product	Outline	Target Version
ID78K0-QB	78K0 integrated debugger	V3.20 or earlier

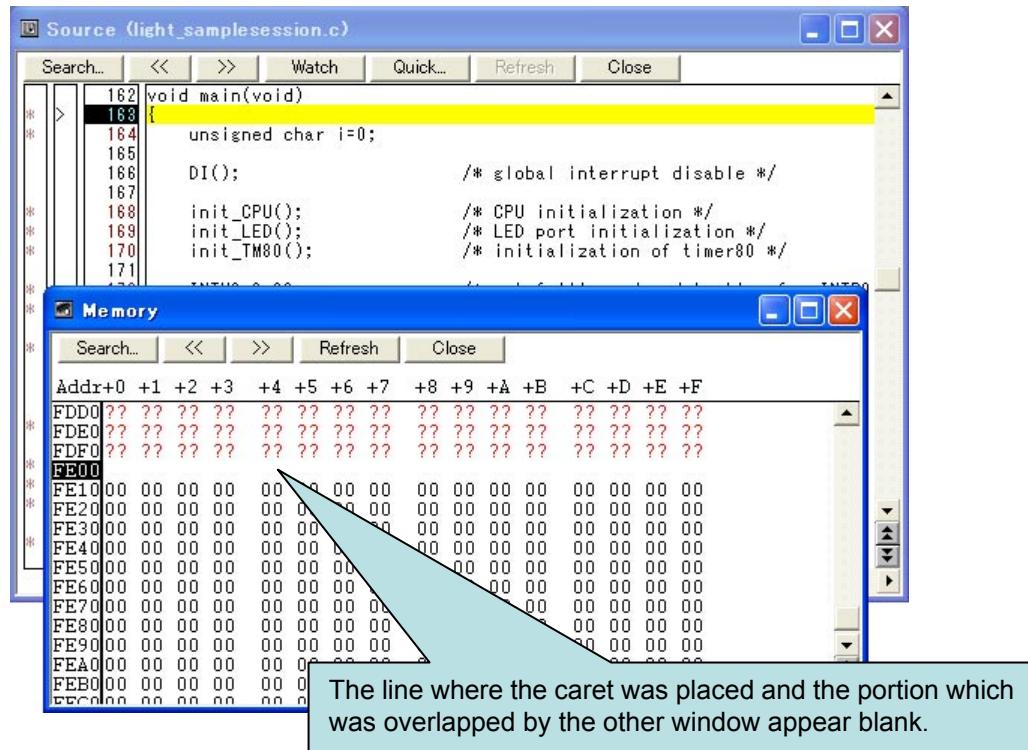
## No. 6 Restriction on redraw <Common>

When the Memory window is displayed in front of another window, if the window behind the Memory window is clicked to the front and then the Memory window is clicked to the front again, the line where the caret was placed and the portion which was overlapped by the other window appear blank in the Memory window.

Click the [Refresh] button or click on the blanked line to restore the original display.

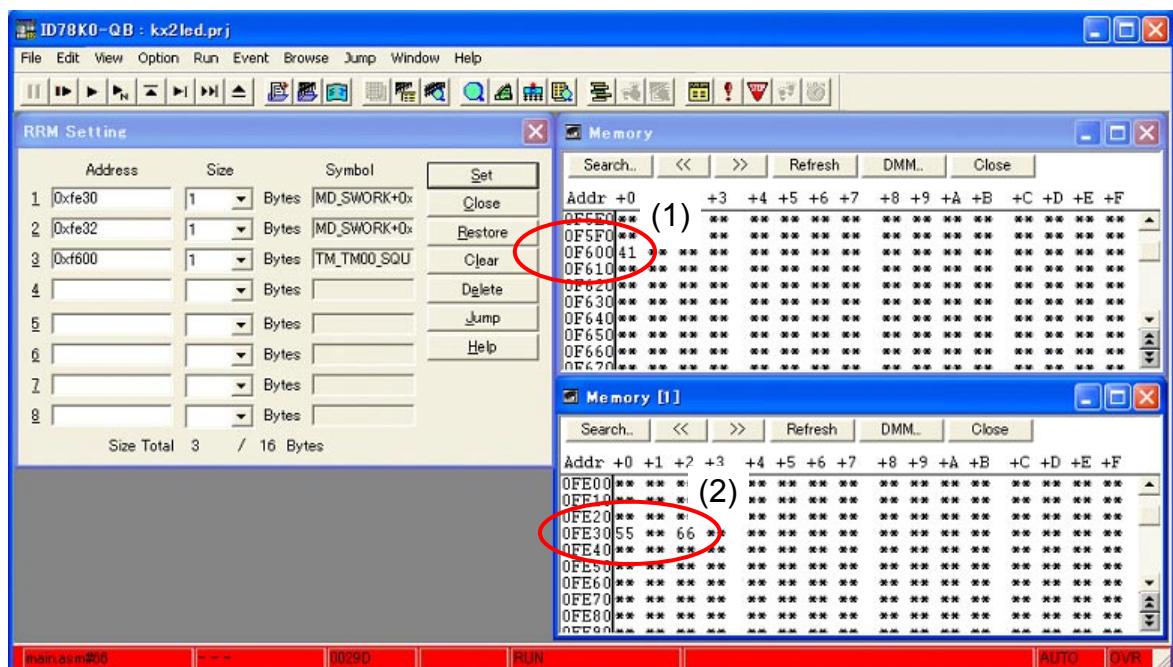
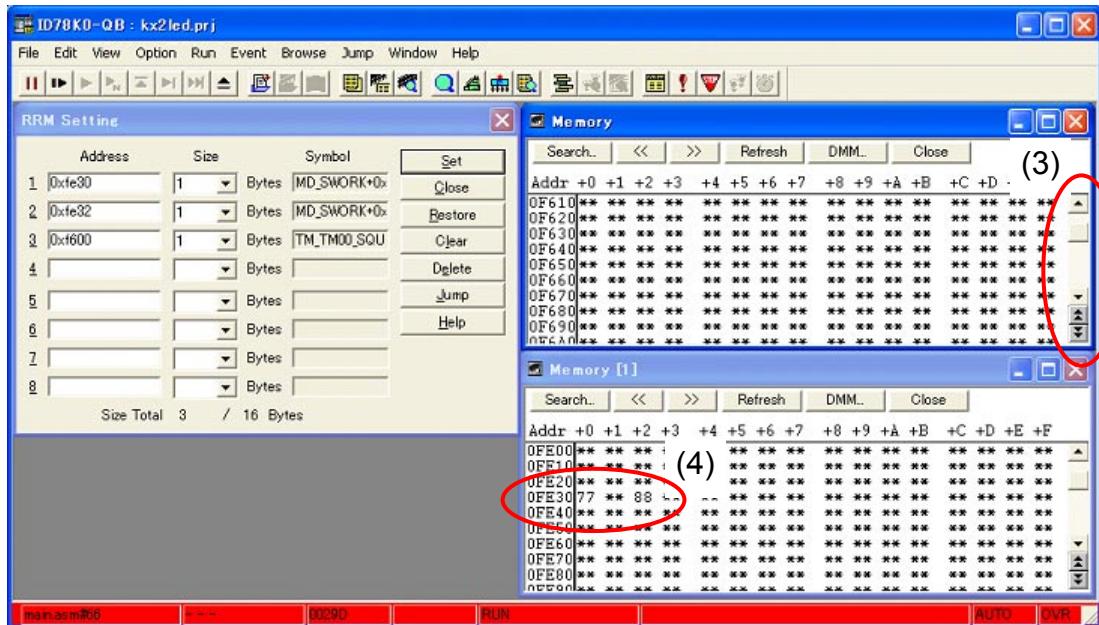
If multiple pseudo RRM addresses are set without making the lowest address that has been set to the RRM target to be viewed in the Memory window or Watch window, the other RRM-target addresses will not be updated.

**Example** Pseudo RRM is executed for addresses 0xF600, 0xFE30 and 0xFE32 in byte units. If 0xF600, the lowest address among the addresses specified for RRM, is displayed in area (1), 0xFE30 and 0xFE32 of (2) are also updated.

However, if the window is scrolled with the scroll bar (3) and 0xF600 is hidden, 0xFE30 and 0xFE32 of (4) are not updated.

Displays multiple Memory windows or always view the lowest address in the Watch window.

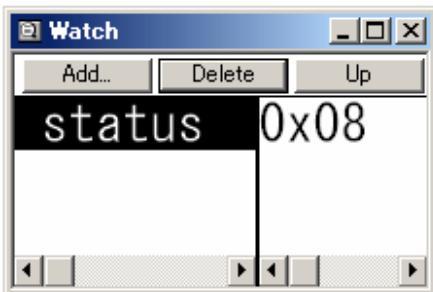
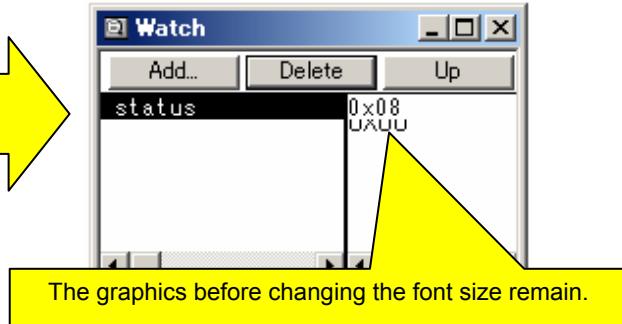
The font size in the Watch window and Local Variable window can be specified by using the [Font] button in the Debugger Option dialog box, which is opened by selecting the [Option] menu and then [Debugger Option...], but if the font size is reduced, the graphics before changing the font size remain in the window.

Example of Watch window:  
Font size: Large

Font size: Small

When such a case occurs, minimize the window once and then restore the window size, or close the window once and then open it again.

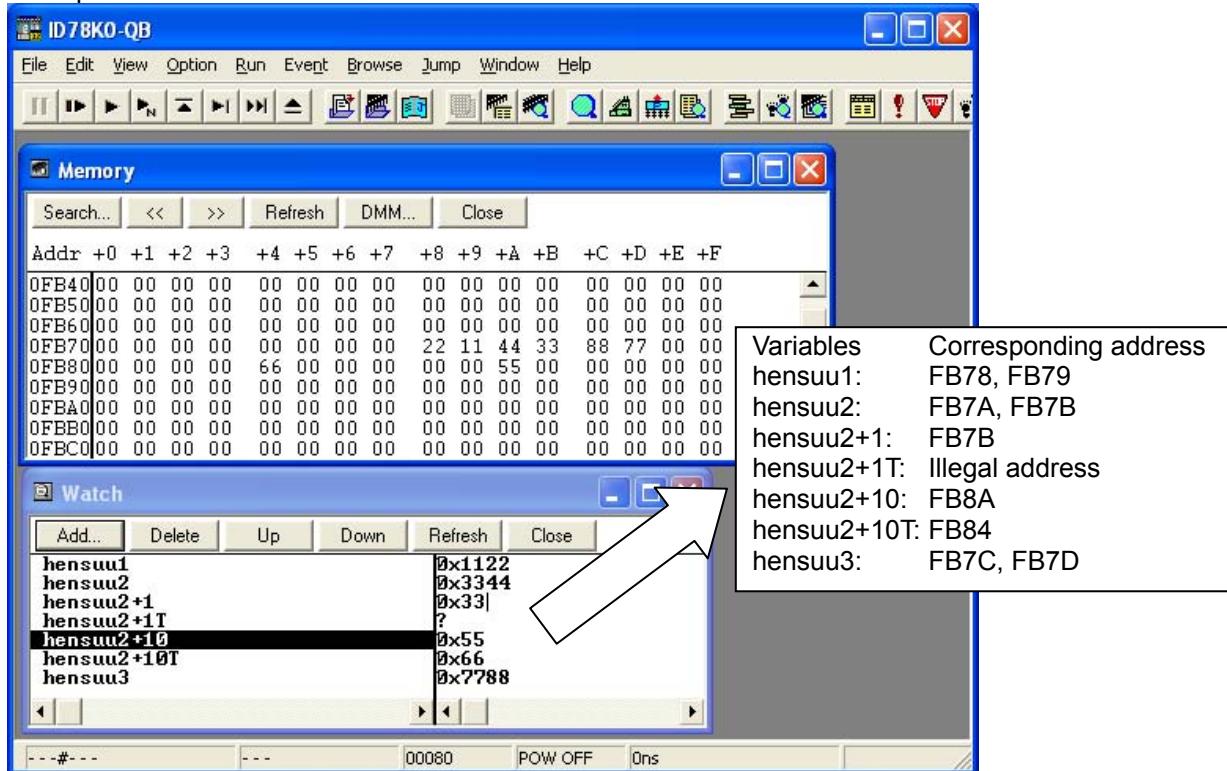
When an address is specified by the debugger using the format of "variable name" + "numeric value", 0T to 9T are not recognized as numeric values and addresses that contain these values become invalid.

Example: When "0T" is used in the Watch window

Use "0 to 9" instead of "0T to 9T".
