CUSTOMER NOTIFICATION

SUD-DT-04-0192 (1/15)
April 13, 2004
Koji Nishibayashi, Senior System Integrator Microcomputer Group 2nd Solutions Division Solutions Operations Unit NEC Electronics Corporation

IE-703107-MC-EM1
(Control Code: A, B, C, D, E)

Operating Precautions

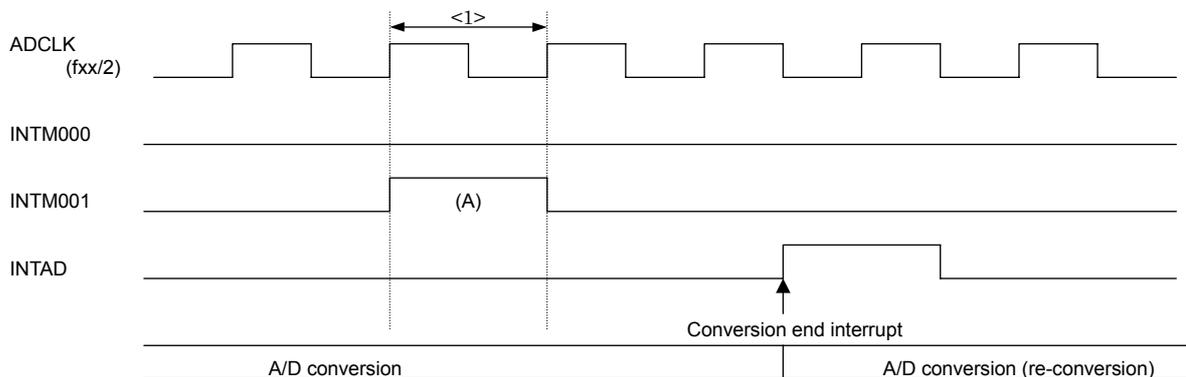
[Example of timing at which this bug occurs]

No.13 Restriction on A/D converter

This restriction occurs when the timer 1 trigger mode or external trigger mode of the A/D converter is used (this bug does not occur when the A/D trigger mode or timer 4 trigger mode is used).

Originally, only INTM000 can be the trigger to start the A/D converter in the timer 1 trigger mode, and ADTRG pin input in the external trigger mode, therefore the interrupt sources listed below should be ignored. However, if one of the interrupt sources listed below occurs immediately before the end of A/D conversion (<1> in the figure below; 2 internal system clocks), it is mistakenly judged as the A/D conversion start trigger. As a result, A/D conversion is started again after the A/D conversion end interrupt (INTAD) is issued. The first A/D conversion ends correctly and the result is stored in the ADCRn register (this value can be read during the second conversion).

The restarted A/D converter performs the conversion operation correctly, issues the A/D conversion end interrupt (INTAD) and stops. The result is overwritten to the ADCRn register.

Note The external interrupt signal that functions alternately as the external capture trigger input of timer C (channels 0 and 1) can also be a trigger for re-conversion. In the case of an external interrupt input, this bug occurs when a valid edge is input before the timing of (A) in the figure below by the noise eliminator (analog delay (60 to 220 ns)).

Since the conversion result is correct even when this bug occurs, the affect of this bug is small when obtaining the latest conversion value. If the re-conversion causes any problems, start A/D conversion in the A/D trigger mode by setting the ADCE bit of the ADM0 register to 1 in the interrupt service routine of the timer match interrupt.

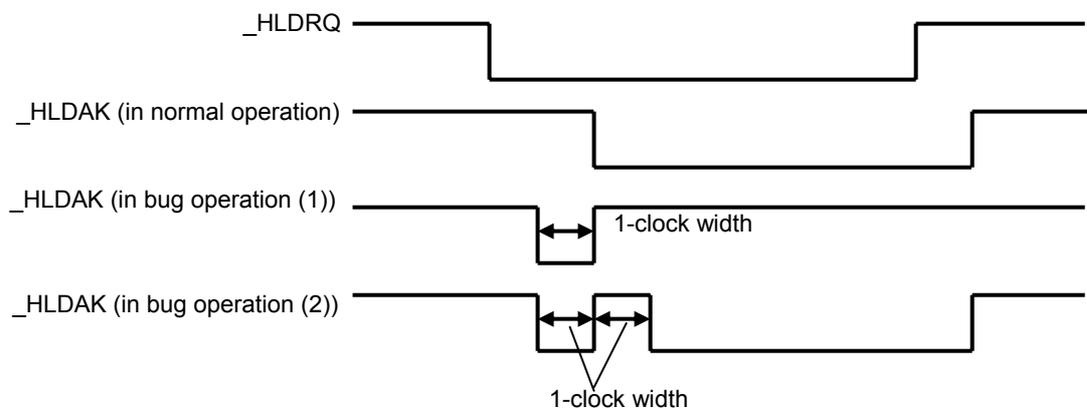
No.14 Bug in _HLDK signal output

The _HLDK signal output from the emulator in response to the _HLDRQ signal from the target system may be illegal (there are two cases).

This bug occurs only when output of the _HLDK signal and refresh conflict.

There is no workaround.

This restriction has been corrected in the IE-703107-MC-EM1 with control code E or later.
