CUSTOMER NOTIFICATION

SUD-DT-04-0197 (1/7)

IE-703217-G1-EM1
(Control Code: A, B, C, D)

Operating Precautions

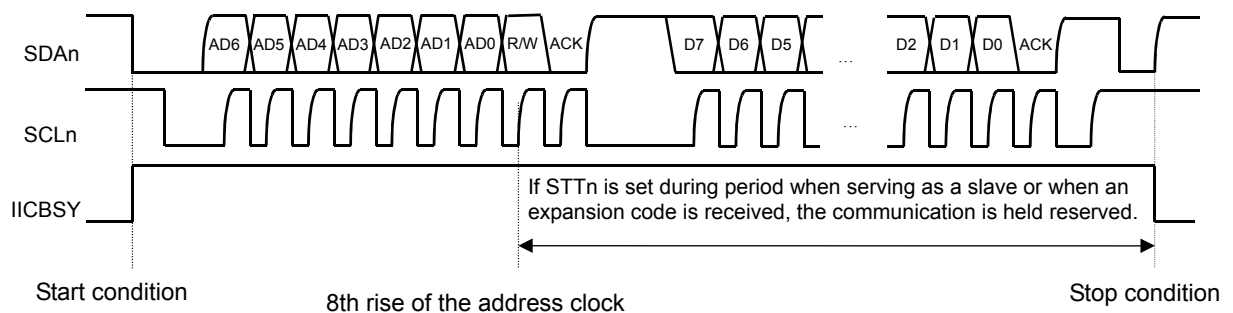
No.6 Restriction on IIC bus communication reservation

If conditions (1) and (2) are satisfied when using the IIC bus interface (IICn), the communication is held reserved even if communication reservation is disabled ($IICRSVn = 1$). At this time, the start condition clear flag (STCFn) is not set ($n = 0$ or 1). (See the figure below.)

- (1) When the address value and the slave address register (SVAn) value match or when an expansion code is received
- (2) When the start condition trigger (STTn) is set in the period from the 8th rise of the address clock to stop condition detection.

This bug occurs when the bus flag (IICBSY) is being set. Before generating the start condition (STTn \leftarrow 1) while communication reservation is disabled (IICRSVn = 1), confirm that the IIC bus status flag has been cleared (IICBSYn = 0).

STTn can be set immediately after IICBSYn = 0 is confirmed, but it is recommended to disable interrupts because if it takes a long time to set STTn due to an interrupt, the start condition may be detected during the period, and a slave match may occur or expansion code may be received at the 8th address clock.

This restriction has been corrected in control code C.

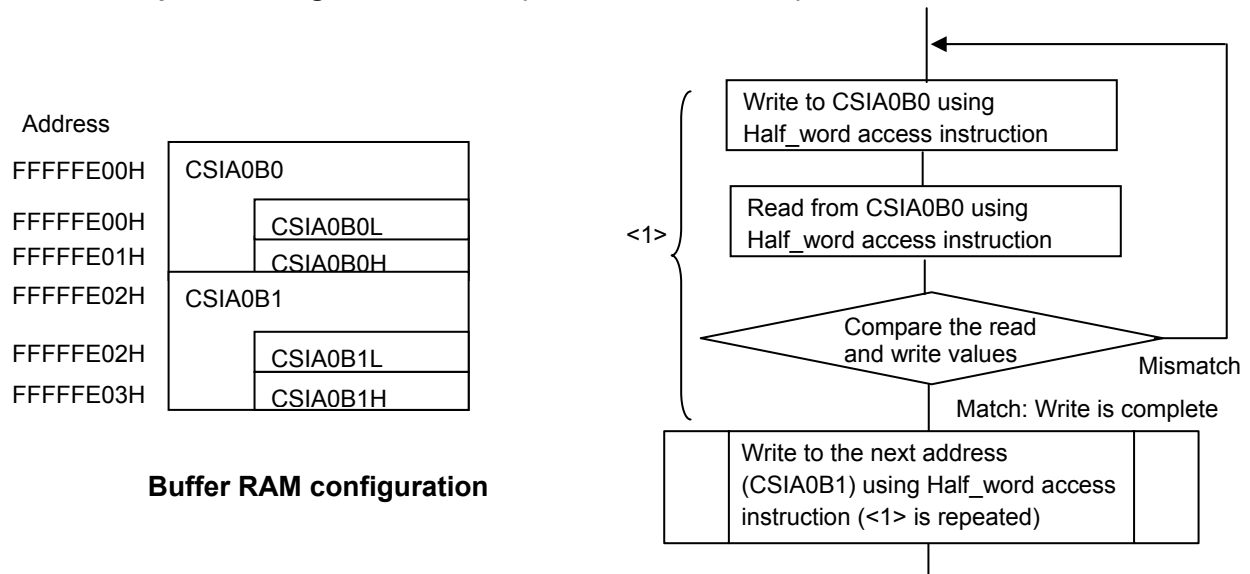
<Example of writing to buffer RAM (CSIA0B0 to CSIA0B1)>

When writing transmit data to the buffer RAM (CSIANBm) using the 3-wire serial interface with automatic transfer function (CSIAN), data may not be written correctly depending on the instruction executed next to the write instruction (n = 0 or 1, m = 0 to F).

After data is written, read the data using the Half_Word access instruction (ST.H) and compare the values. If the data do not match, perform the write again. At this time, it is not necessary to disable interrupts.

When writing an odd number of bytes, write dummy data to the buffer RAM (CSIANBmH) at the higher address. The Half_Word access instruction must be used to access registers until the compare result matches and write is confirmed.
