CUSTOMER NOTIFICATION

SUD-DT-04-0193 (1/11)

QB-V850ESSX2
(Control Code: A, B, C)

Operating Precautions

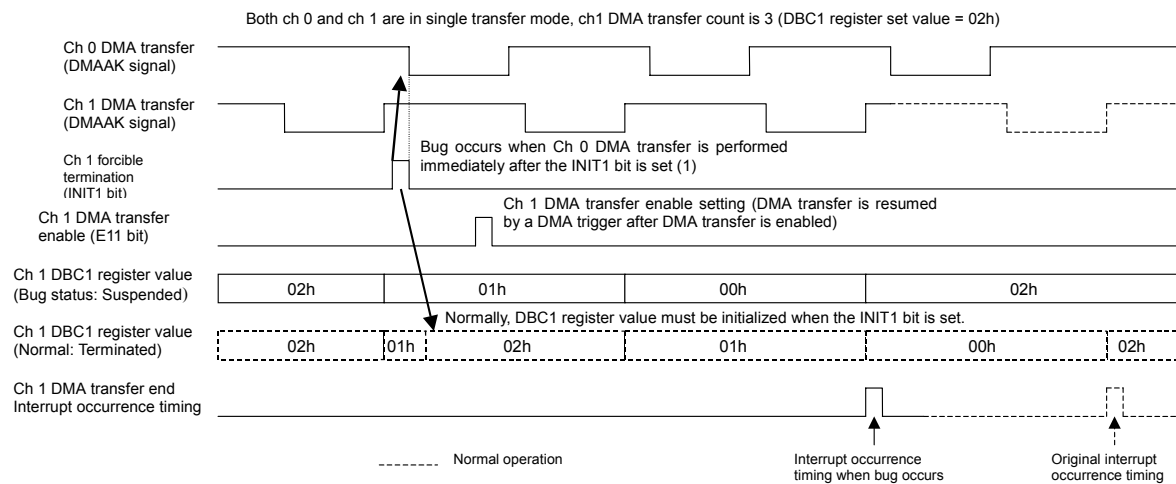
No.10 Bug related to DMA transfer forcible termination

When terminating a DMA transfer by setting the INITn bit of the DCHCn register, the transfer may not be terminated, but just suspended, even though the INITn bit is set (1). As a result, when the DMA transfer of a channel that should have been terminated is resumed, the DMA transfer will terminate after an unexpected number of transfers are completed and a DMA transfer completion interrupt may occur (n = 0 to 3). This bug occurs if a DMA transfer is executed immediately after a forcible termination is set (by setting the INITn bit) (see the figure below).

This bug does not depend on the number of transfer channels, transfer type (2-cycle or flyby), transfer target (between memory and memory, memory and I/O; including internal resources), transfer mode (single, single-step, or block), or trigger (external request, interrupt from internal peripheral I/O, or software), and can occur with any combination of the above elements that can be set under the specifications. In addition, another channel may affect the occurrence of this bug.

The following registers are buffer registers with a 2-stage FIFO configuration of master and slave. If these registers are overwritten during a DMA transfer or in the DMA-suspended status, the value is written to the master register, and reflected in the slave register when the DMA transfer of the overwritten channel is terminated.

The “initialization” in the above figure means that the contents of the master register are reflected in the slave register.

This bug can be avoided by implementing any of the following procedures using the software.

(2) Repeat setting the INITn bit until the forcible DMA transfer termination is correctly performed (n = 0 to 3)

- <1> Copy the initial transfer count of the channel that should be terminated forcibly to a general-purpose register.
- <2> Set (1) the INITn bit of the DCHCn register of the channel that should be terminated forcibly.
- <3> Read the value of the DMA transfer count register (DBCn) of the channel that should be terminated forcibly and compare the value with the one copied in <1>. If the values do not match, repeat <2> and <3>.

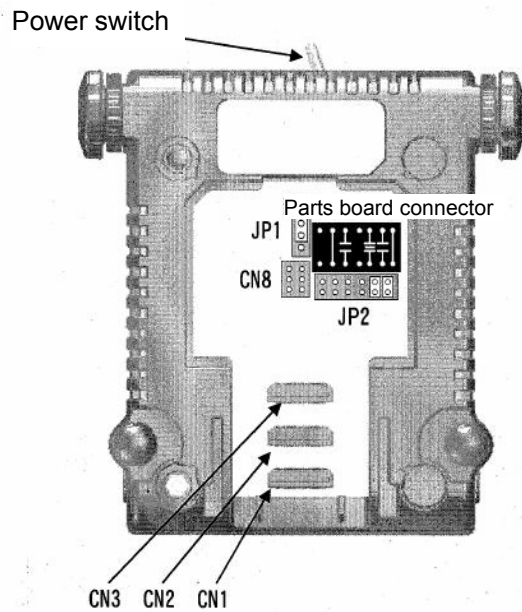
Parts layout in control codes A and B

The parts layout has been modified in control code C or later as shown below.

This modification facilitates connection and disconnection of the parts board and jumpers.
