RENESAS TECHNICAL UPDATE

Classification of Production	MPU&MCU		No	TN-SH7-494A/E	Rev	1
THEME	SH7760 type number change due to logical modification.		Classification of Information	1. Spec change 2. Supplement of Documents 3. Limitation of Use ④ Change of Mask 5. Change of Production Line		
PRODUCT NAME	HD6417760BP200D HD6417760BP200DV	Lot No.	Reference Documents	SH7760 hardware manual Rev 1.0 (ADE-602-291)	Effective Date	
		All			Eternity

The mask of SH7760(HD6417760) is changed due to logical modifications described below. Please see the following new type number.

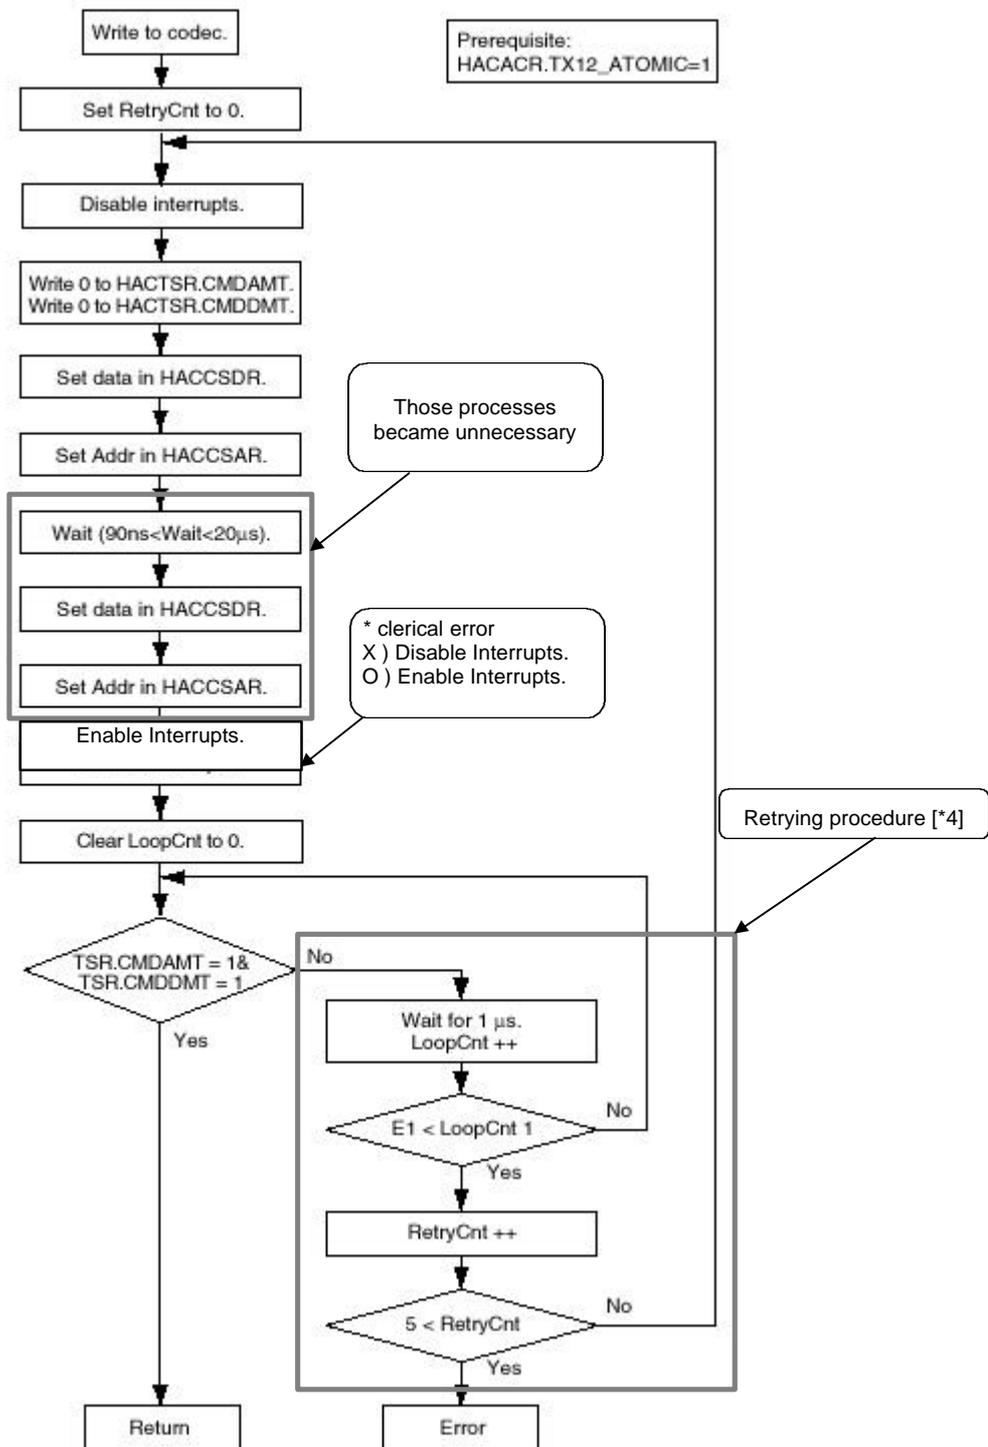
Figure 1. Modification for Figure 25.4 in Hardware Manual Rev 1.0

HD6417760BP200AD/ADV : There is no need to apply this restriction. Please see Figure 1 and 2.

(*4) : Some CODEC devices may not complete accessing CODEC register within 1 slot time.
In this case, please execute this retrying procedure.
