RENESAS TECHNICAL UPDATE

Product Category	MPU & MCU	Document No.	TN-16C-A235A/E	Rev.	1.00
Title	Errata to R32C/151 Group User's Manual: Hardware		Information Category	Technical Notification	
Applicable Product	R32C/151 Group	Lot No.	Reference Document	R32C/151 Group User's Manual: Hardware Rev. 1.10 (REJ09B0503-0110)

This document describes corrections to the R32C/151 Group User's Manual: Hardware, Rev. 1.10. The corrections are indicated in red in the list below.

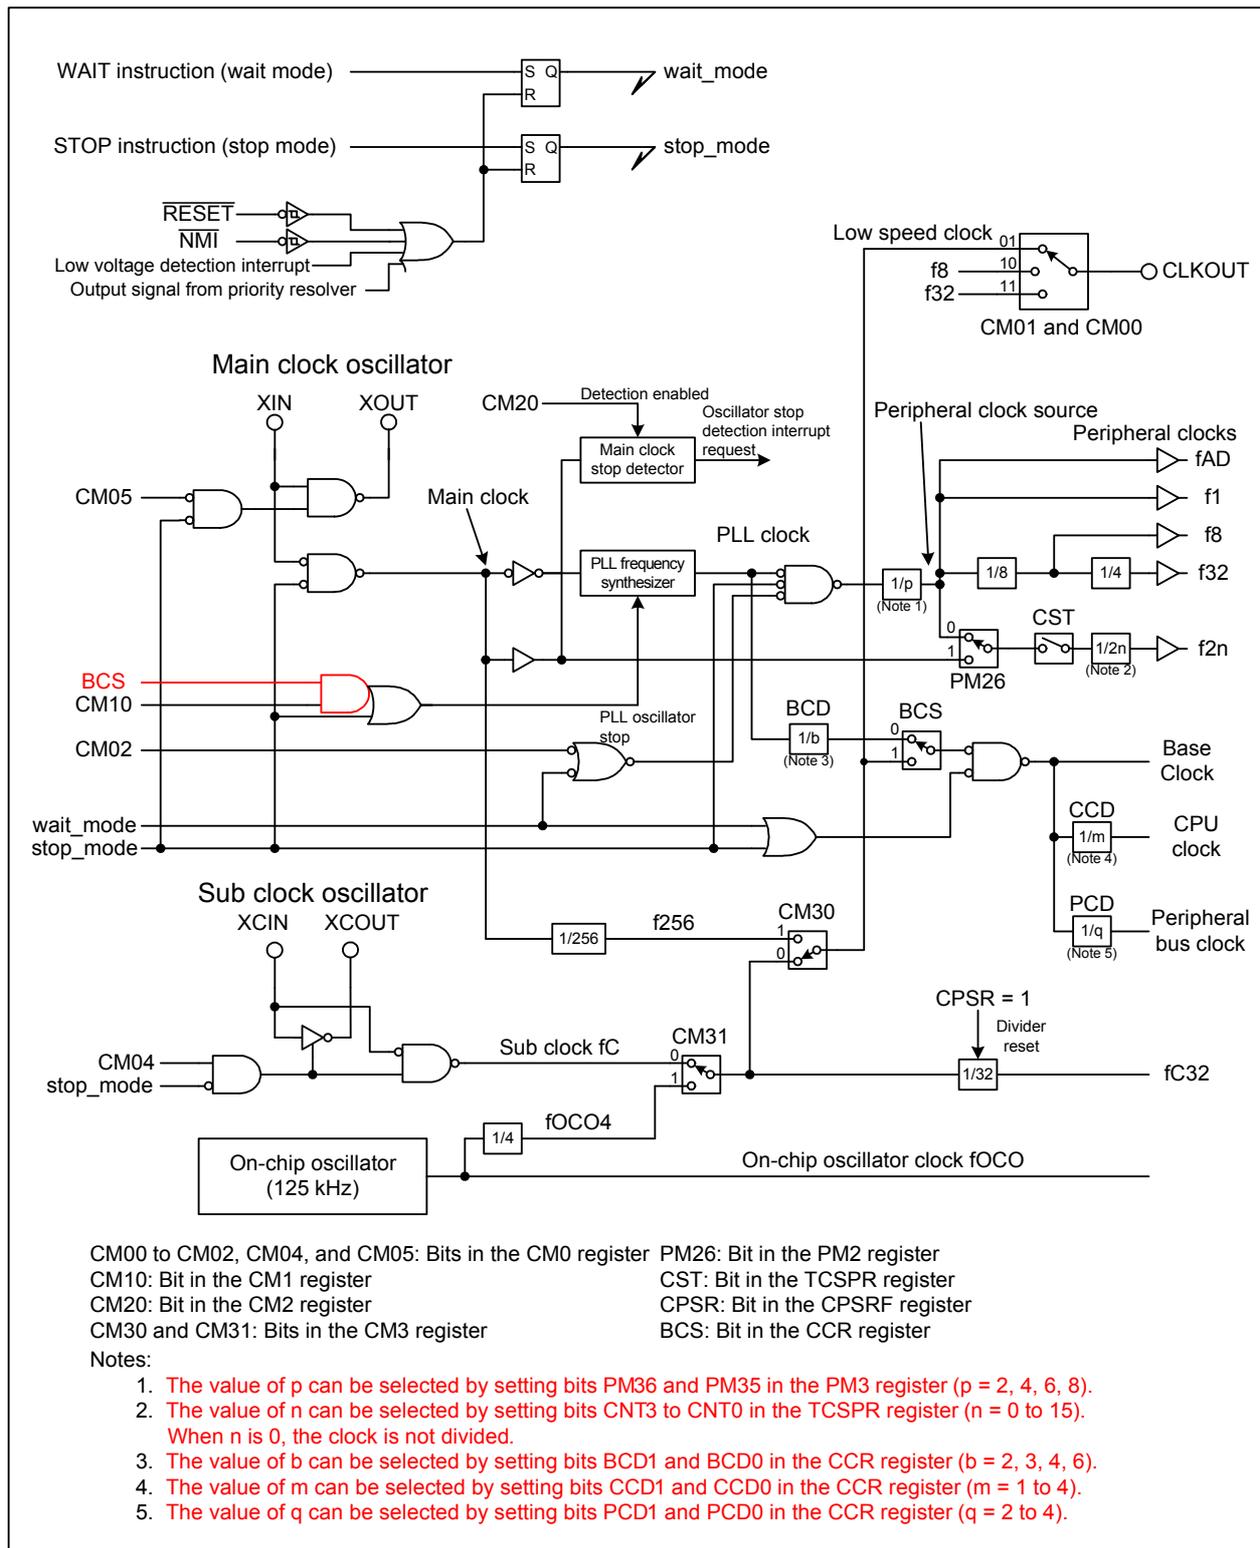
Figure 7.1 Clock Generation Circuitry

•Page 91 of 628, Figure 7.1 is corrected as follows:

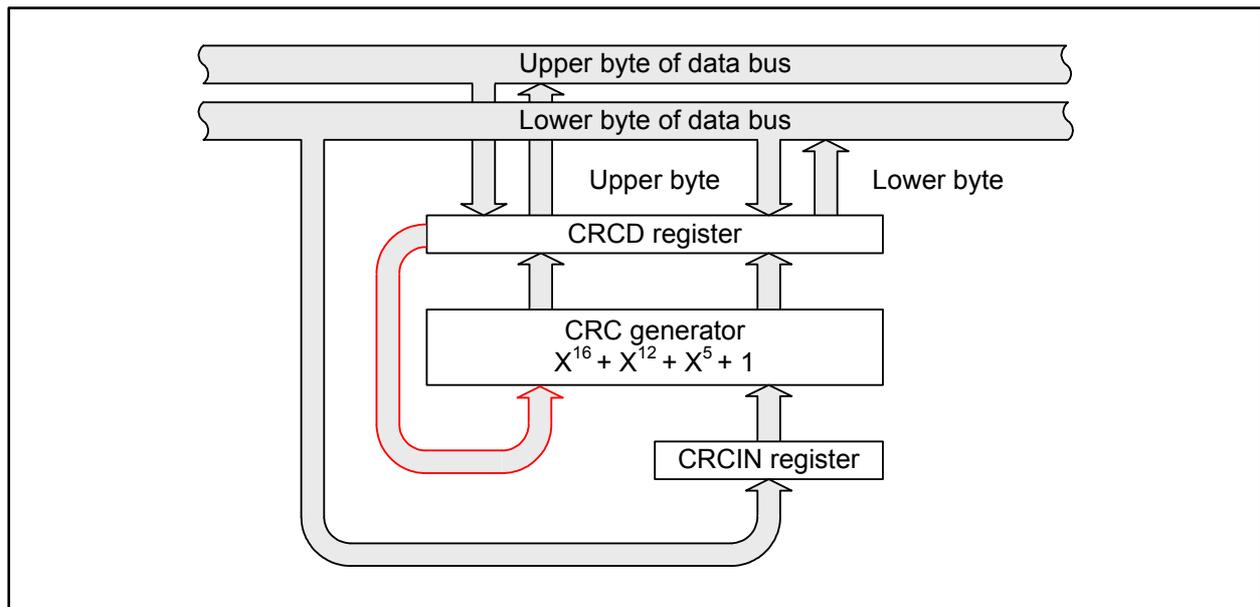
Figure 20.1 CRC Calculator Block Diagram

•Page 313 of 628, Figure 20.1 is corrected as follows:

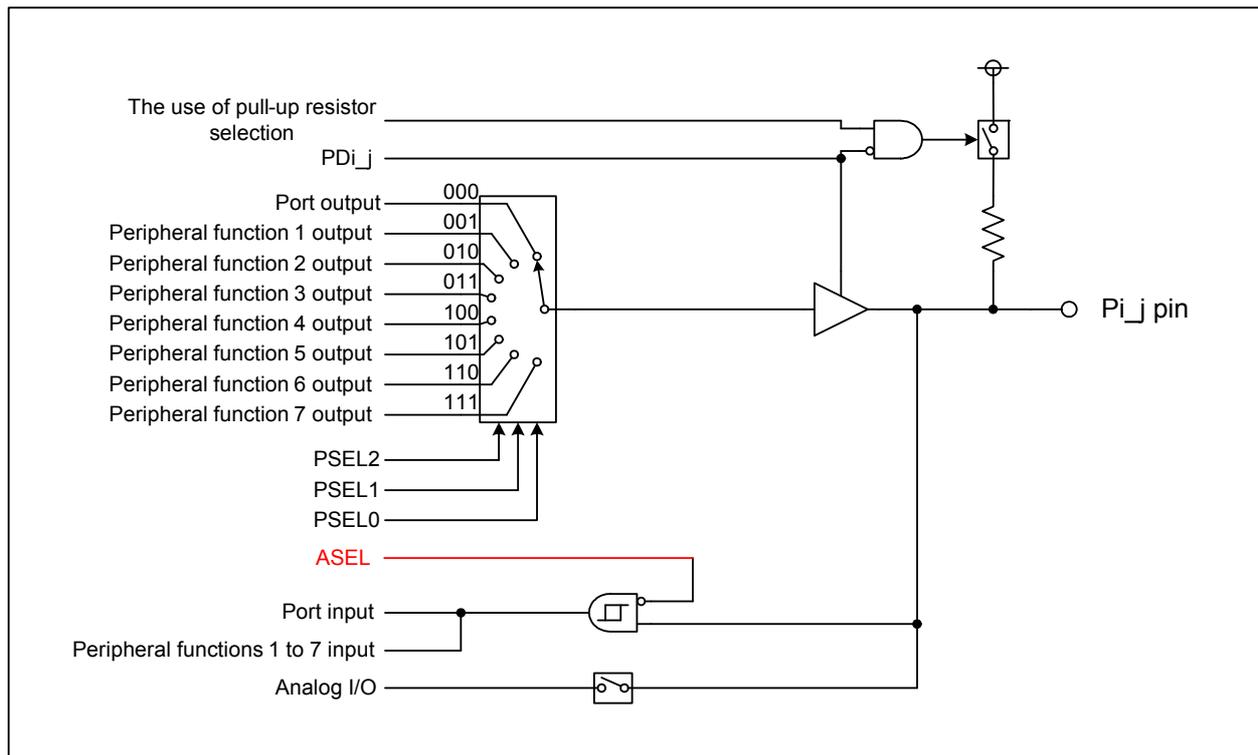
Figure 26.1 Typical I/O Pin Block Diagram (i = 0 to 15; j = 0 to 7)

•Page 497 of 628, Figure 256.1 is corrected as follows (refer to TN-16C-A200A/E):
