# RENESAS TECHNICAL UPDATE

Product Category	MPU/MCU		Document No.	TN-RH8-B0111D/E	Rev.	4.00
Title	Errata of RH850/E1x User's Manual Hardware Rev.1.20		Information Category	Technical Notification		
Applicable Product	RH850/E1x-FCC1 RH850/E1M-S RH850/E1L	Lot No.	Reference Document	Refer to the below		
		-

This document is errata of "RH850/E1x User's Manual Hardware Rev.1.20".

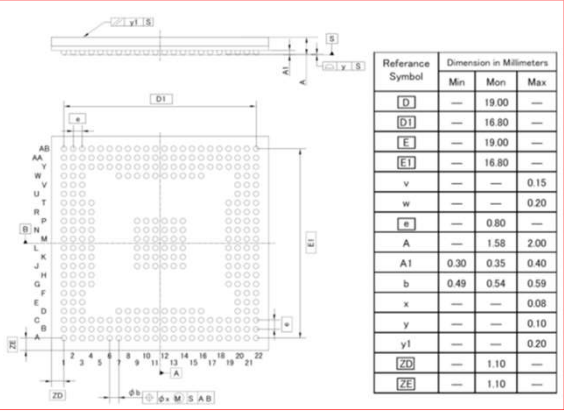
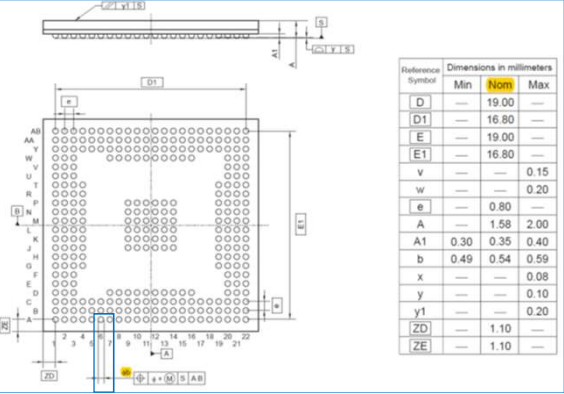
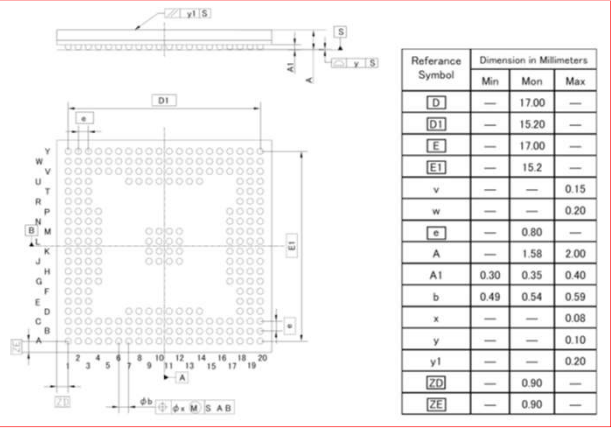
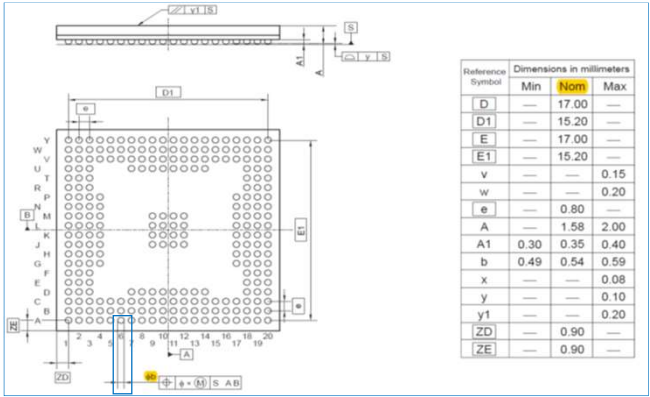
46	E1L only (UM P2262)	Electrical Characteristics	37.3.6 CSIH Timing Note.	● n = 0 to 2, x = 0 to 5 (n = 0), x = 0 to 3 (n = 1, 2, 3)		● n = 0 to 2, x = 0 to 5 (n = 0), x = 0 to 3 (n = 1, 2)		Writing Error	Reported on TECHNICAL UPDATE "TN-RH8-B111C/E".		-	-	2262
47	2645	Electrical Characteristics	Table 37.37 ADC Converter Characteristics (Depending on the product, table number is different.)	A/D conversion time (FOP = 20 MHz, 40 MHz)		A/D conversion time		Writing Error	Reported on TECHNICAL UPDATE "TN-RH8-B111C/E".		2645	2604	2277
48	2853, etc.	Appendix Package Dimensions	Appendix Package Dimensions	Refer to "Package Dimensions (BGA)" sheet.		Refer to "Package Dimensions (BGA)" sheet.		Writing Error	Reported on TECHNICAL UPDATE "TN-RH8-B111C/E".		2853, 2854	2812, 2813	2451

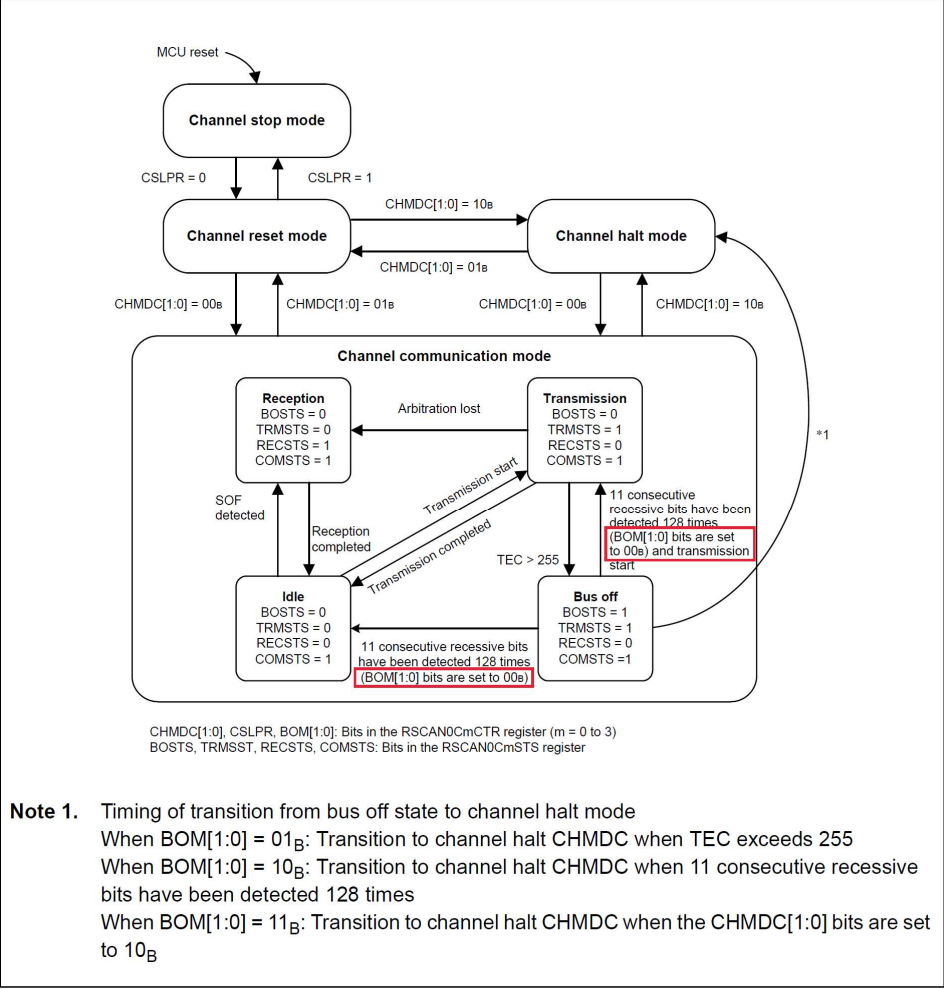
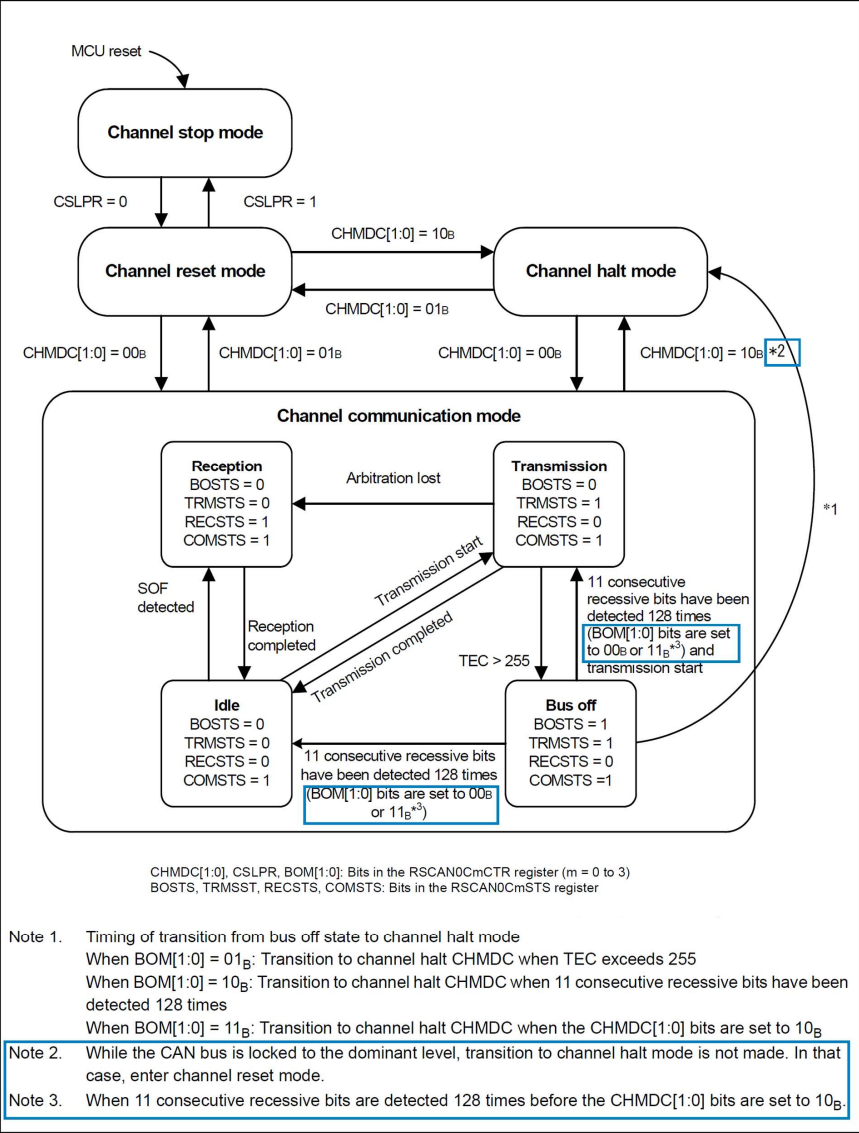
No.56\_Figure 16.5

53	298	CPU System	(4) MPTRGN - MPU end region register @PCU	bit-map 4-0: MPTRGN Table 3.119 MPTRGN Register Contents Bit Position: 31 to 5 4 to 0 MPTRGN	bit-map 3-0: MPTRGN Table 3.119 MPTRGN Register Contents Bit Position: 31 to 4 3 to 0 MPTRGN	Writing Error	Reported on TECHNICAL UPDATE "TN-RH8-B111C/E".	Modified the section title of No. 13.	298	260	253
54	582	CSIH	13.5.10 CSIH interrupt requests (3) INT_CSHTIC (communication status interrupt) Figure 13.25 Generation of INT_CSHTIC in Job Mode			Writing Error	Reported on TECHNICAL UPDATE "TN-RH8-B111C/E".		582	543	534
55	583	CSIH	13.5.10 CSIH interrupt requests (3) INT_CSHTIC (communication status interrupt) Table 13.10 Generation of INT_CSHTIC in Job Mode		The left descriptions marked in red are deleted. 	Writing Error	Reported on TECHNICAL UPDATE "TN-RH8-B111C/E".		583	544	535
56	860	RS-CAN	16.4.2.6 Channel Modes Figure 16.5 Channel Mode State Transition Chart	Refer to "No.56, Figure 16.5" Sheet.	Refer to "No.56, Figure 16.5" Sheet.	Additional Description	Reported on TECHNICAL UPDATE "TN-RH8-B111C/E".		860	821	812
