# RENESAS TECHNICAL UPDATE

Product Category	MPU/MCU		Document No.	TN-RL*-A075A/E	Rev.	1.00
Title	Notice for using RL78/G1H		Information Category	Technical Notification		
Applicable Product	RL78/G1H R5F11Fxxx	Lot No.	Reference Document	RL78/G1H User's Manual: Hardware Rev.1.20 R01UH0575EJ0120(Dec 2016)		
		All lots

This document describes correction of errors in the RL78/G1H User's Manual: Hardware Rev.1.20 (R01UH0575EJ0120)

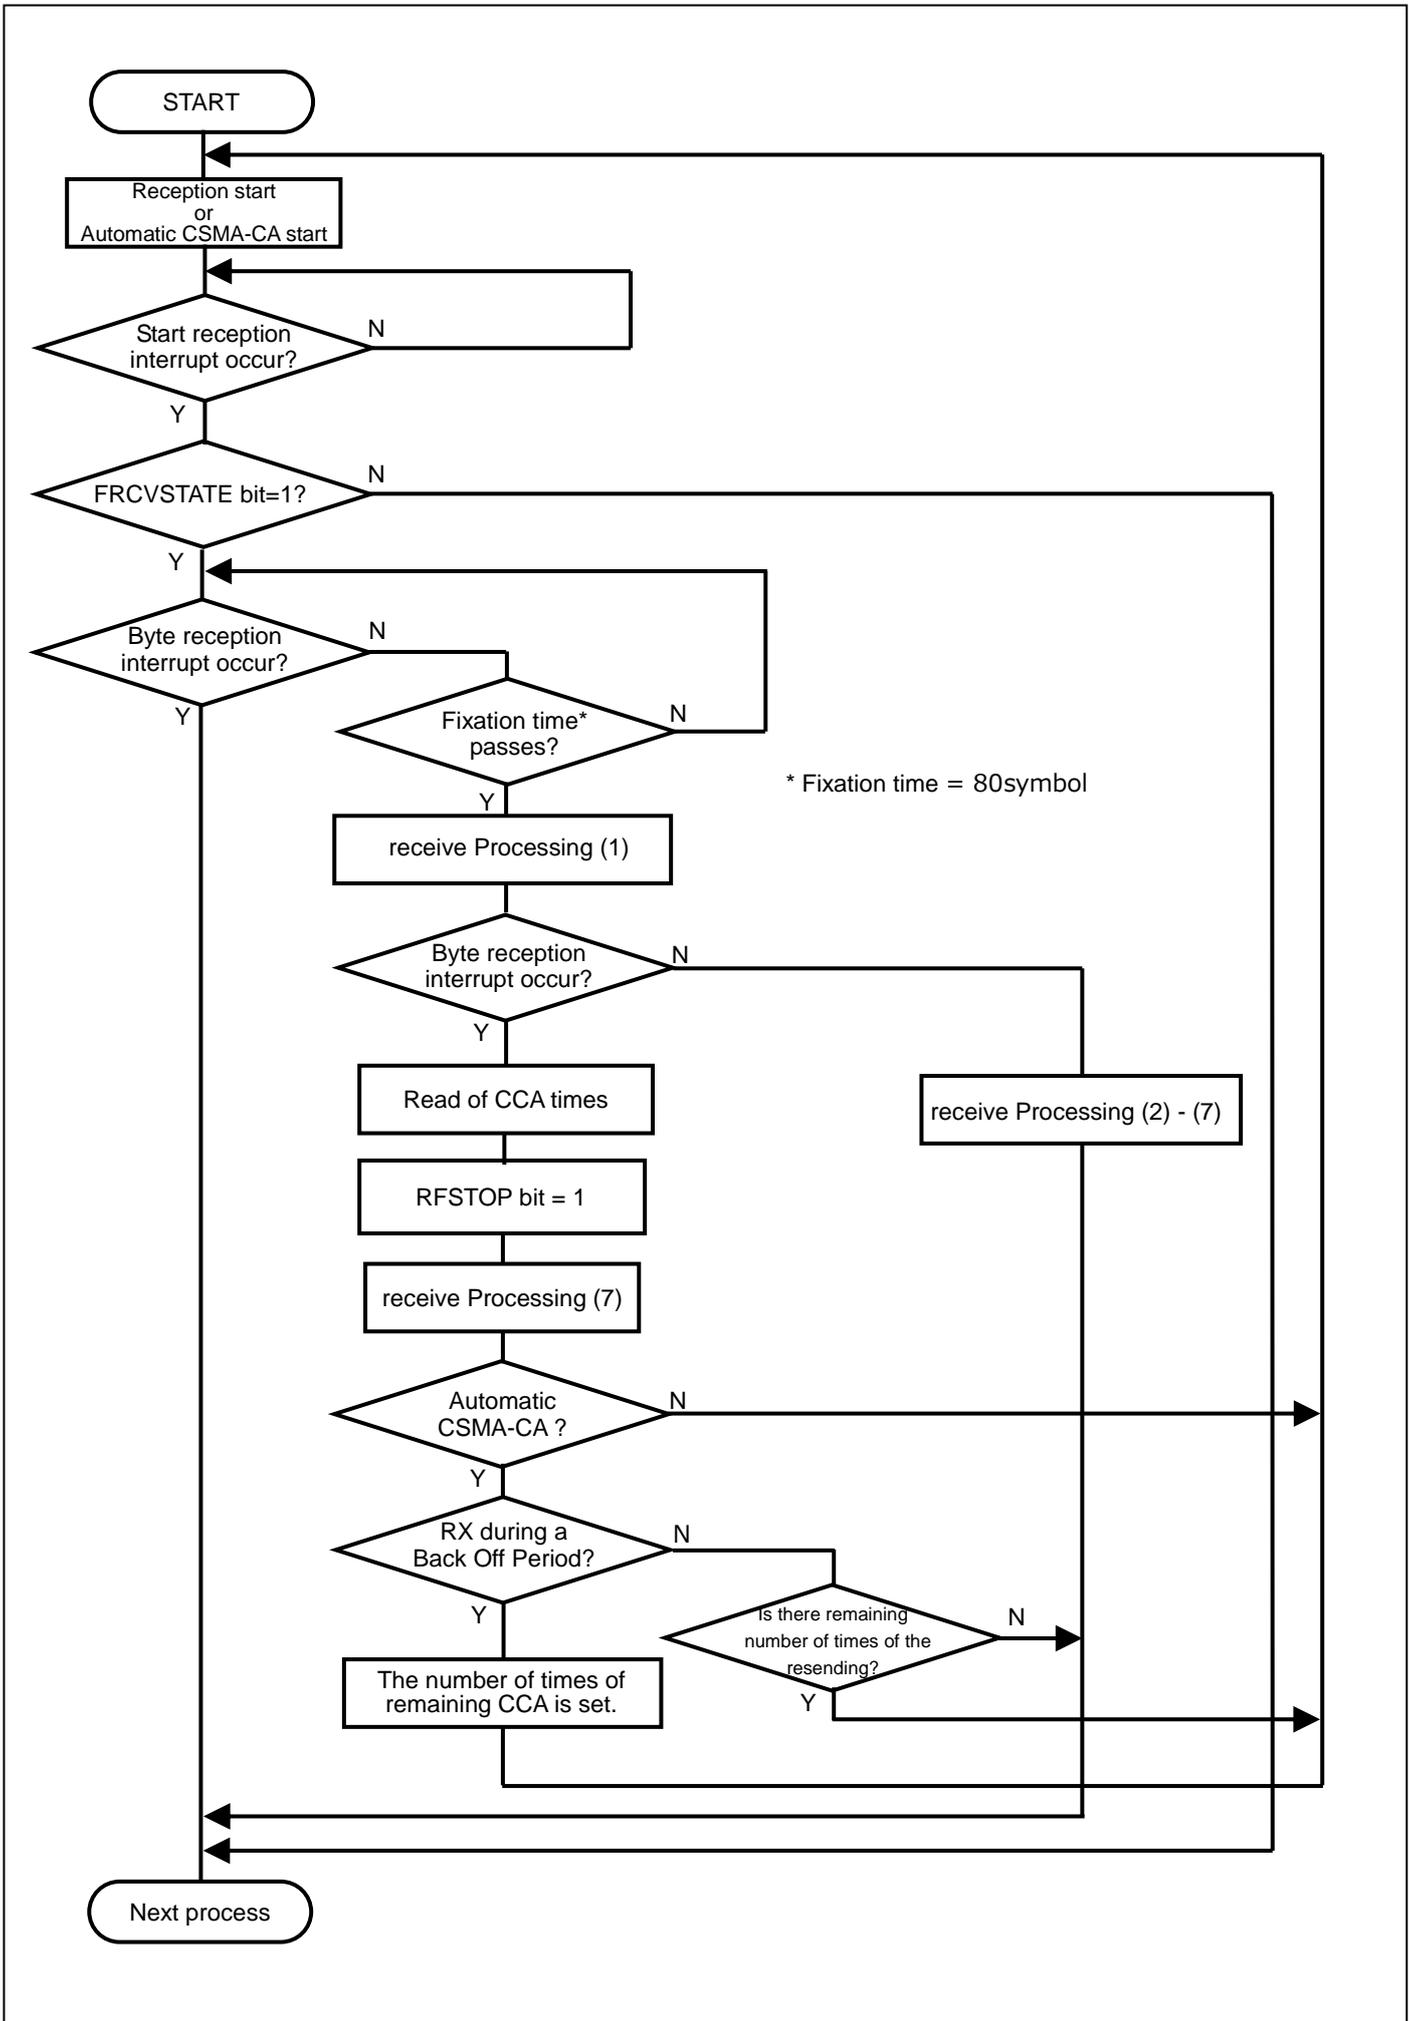
Do the following procedure, when Byte reception interrupt does not occur in the reception mode of using Start reception interrupt and Byte reception interrupt.

The procedure (2) – (6) depend on the situation.

- (1) 0077h address is set to 05h.
- (2) 0077h address is set to 06h.
- (3) 0060h address is set to 0Dh.
- (4) 0063h address is set to 00h.
- (5) 0063h address is set to 00h.
- (6) 0060h address is set to 01h.
- (7) 0077h address is set to 07h.

The details are in the flow chart on the next page.
