RENESAS TECHNICAL UPDATE

Product Category	MPU/MCU		Document No.	TN-RX*-A0241B/E	Rev.	2.00
Title	RX110 Group, RX111 Group Errata to User's Manual: Hardware Regarding the Realtime Clock (RTC)		Information Category	Technical Notification		
Applicable Product	RX110 Group, RX111 Group	Lot No.	Reference Document	RX110 Group User's Manual: Hardware Rev.1.20 (R01UH0421EJ0120) RX111 Group User's Manual: Hardware Rev.1.30 (R01UH0365EJ0130)		
		All

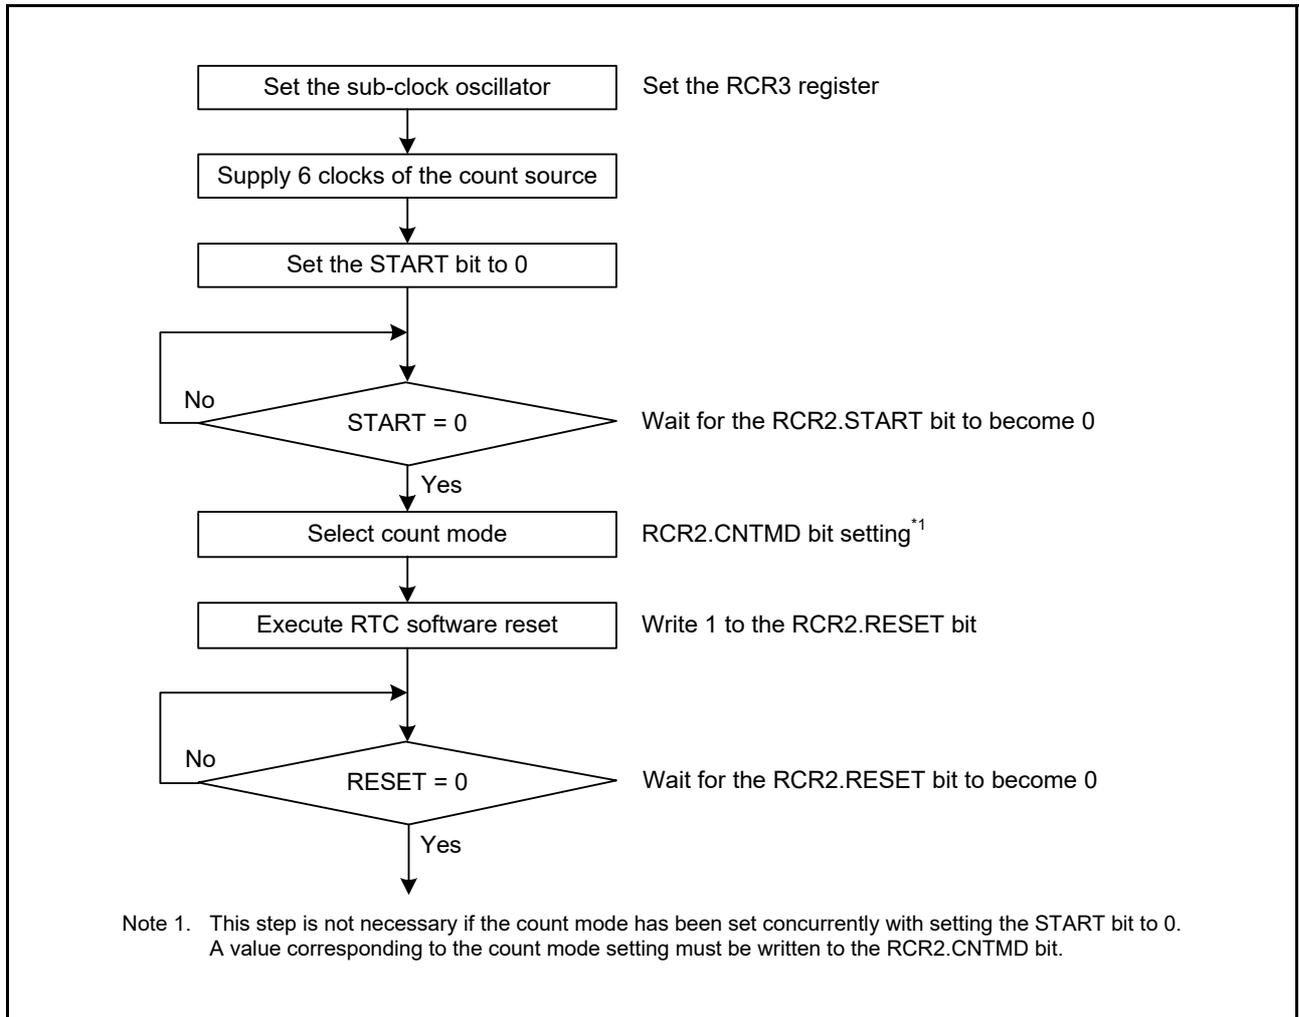
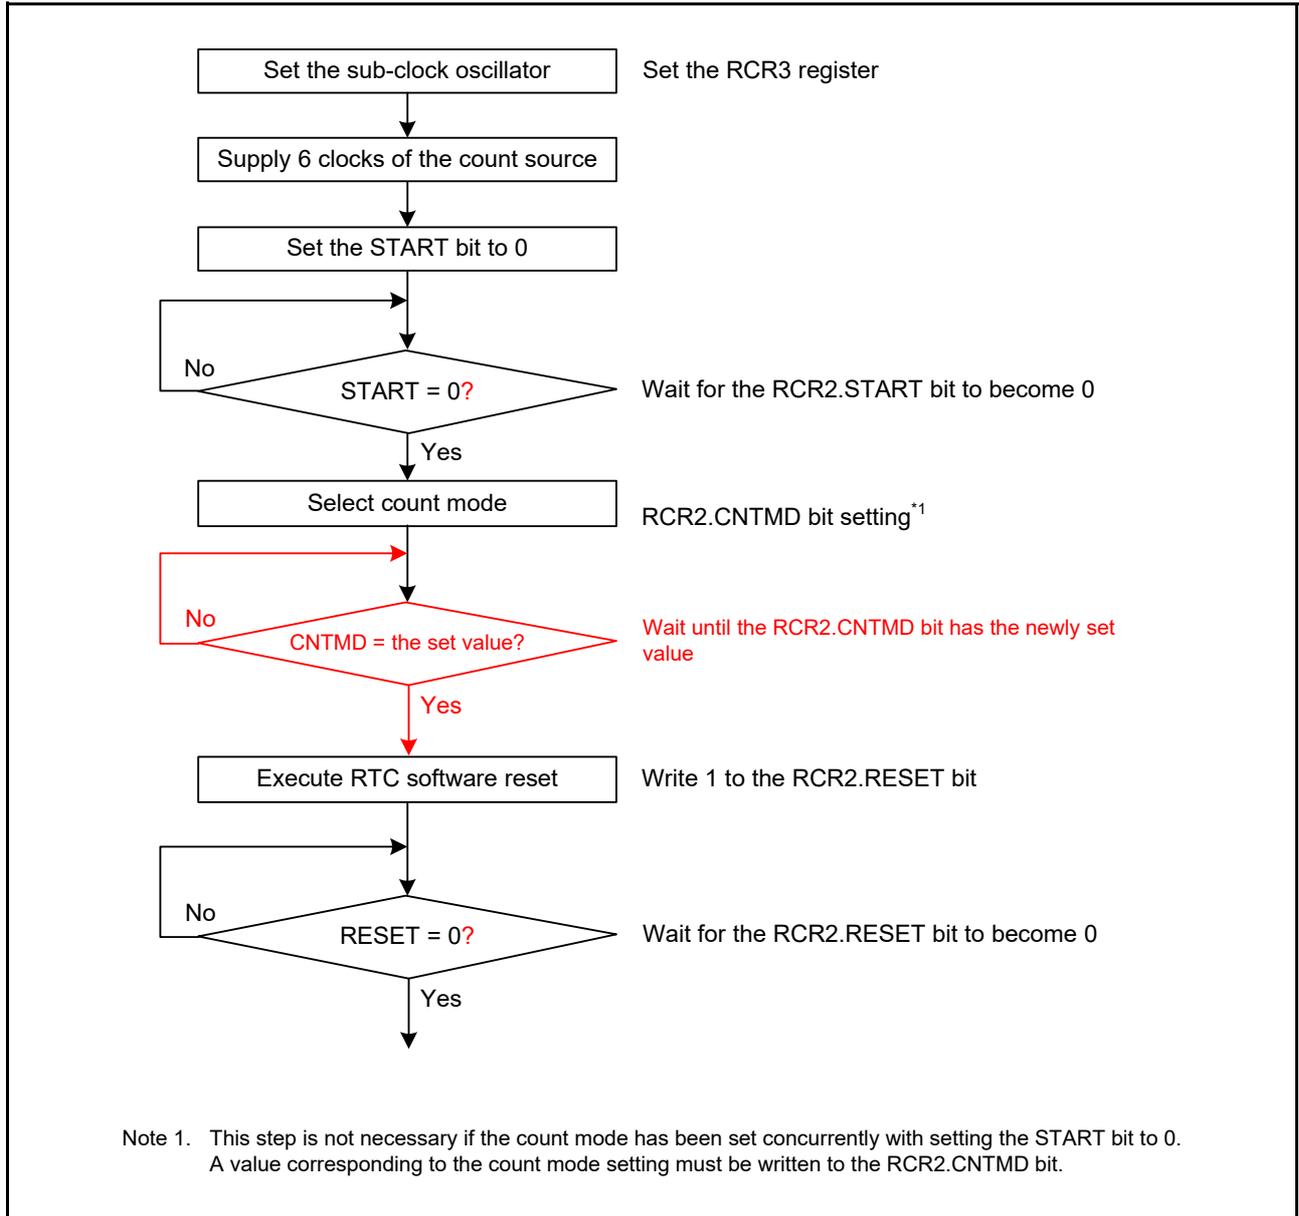
Figure 21.3 Clock and Count Mode Setting Procedure

The setting procedure described in Figure 21.3, Clock and Count Mode Setting Procedure is corrected as follows.

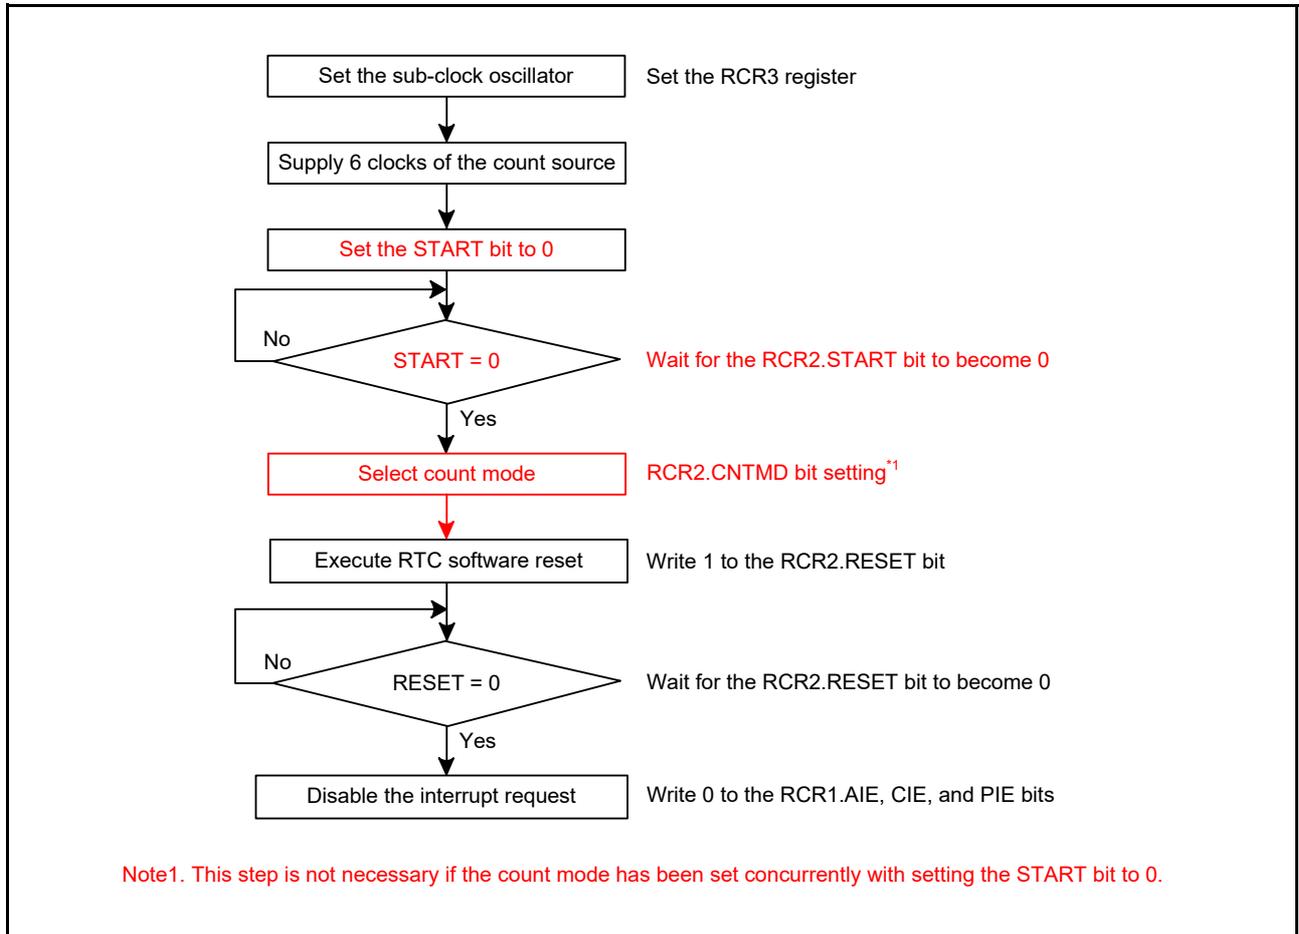
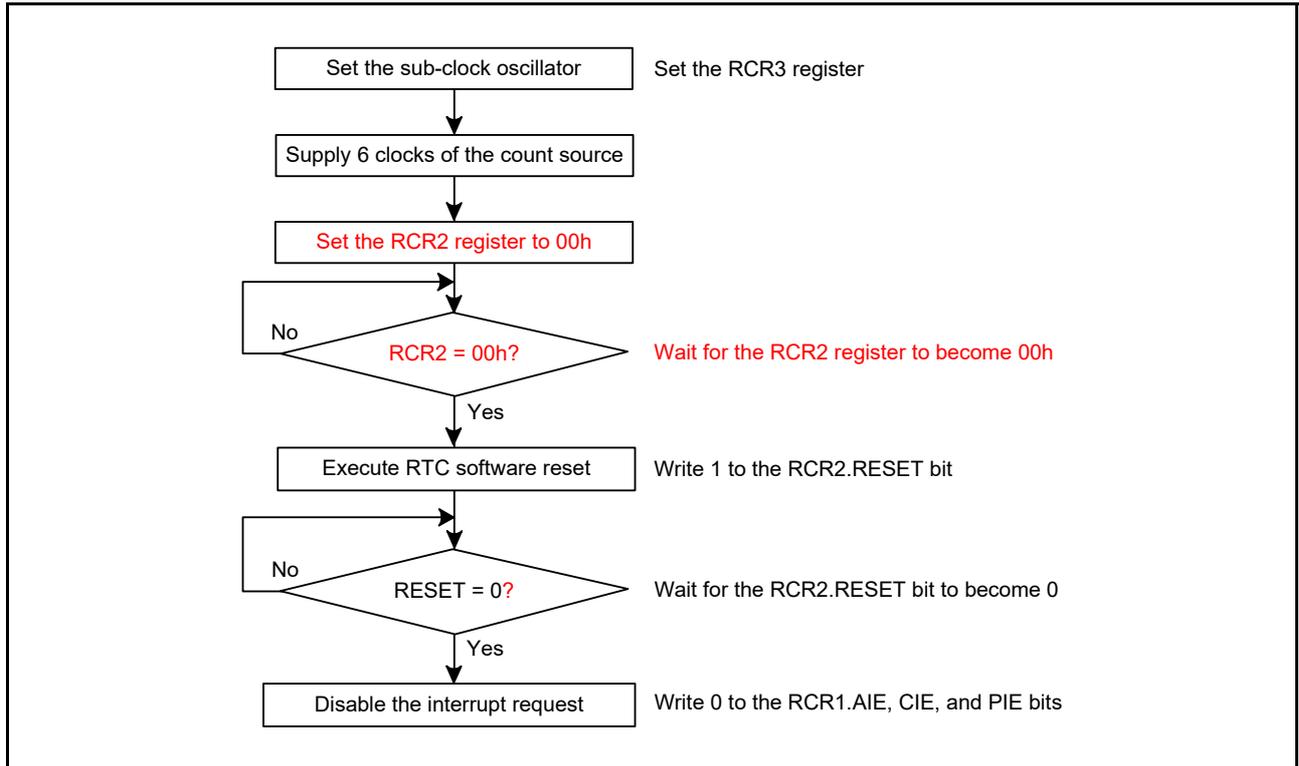
Figure 21.12 Initialization Procedure

The initialization procedure described in Figure 21.12 of section 21.5.7 Initialization Procedure When the Realtime Clock is Not to be Used is corrected as follows.
