# RENESAS TECHNICAL UPDATE

Product Category	MPU/MCU		Document No.	TN-RX*-A0239B/E	Rev.	2.00
Title	RX210 Group Errata to User's Manual: Hardware Regarding the Realtime Clock (RTC)		Information Category	Technical Notification		
Applicable Product	RX210 Group	Lot No.	Reference Document	RX210 Group User's Manual: Hardware Rev.1.50 (R01UH0037EJ0150)		
		All

This document describes corrections to the "Realtime Clock (RTC)" chapter in User's Manual: Hardware for the applicable products.

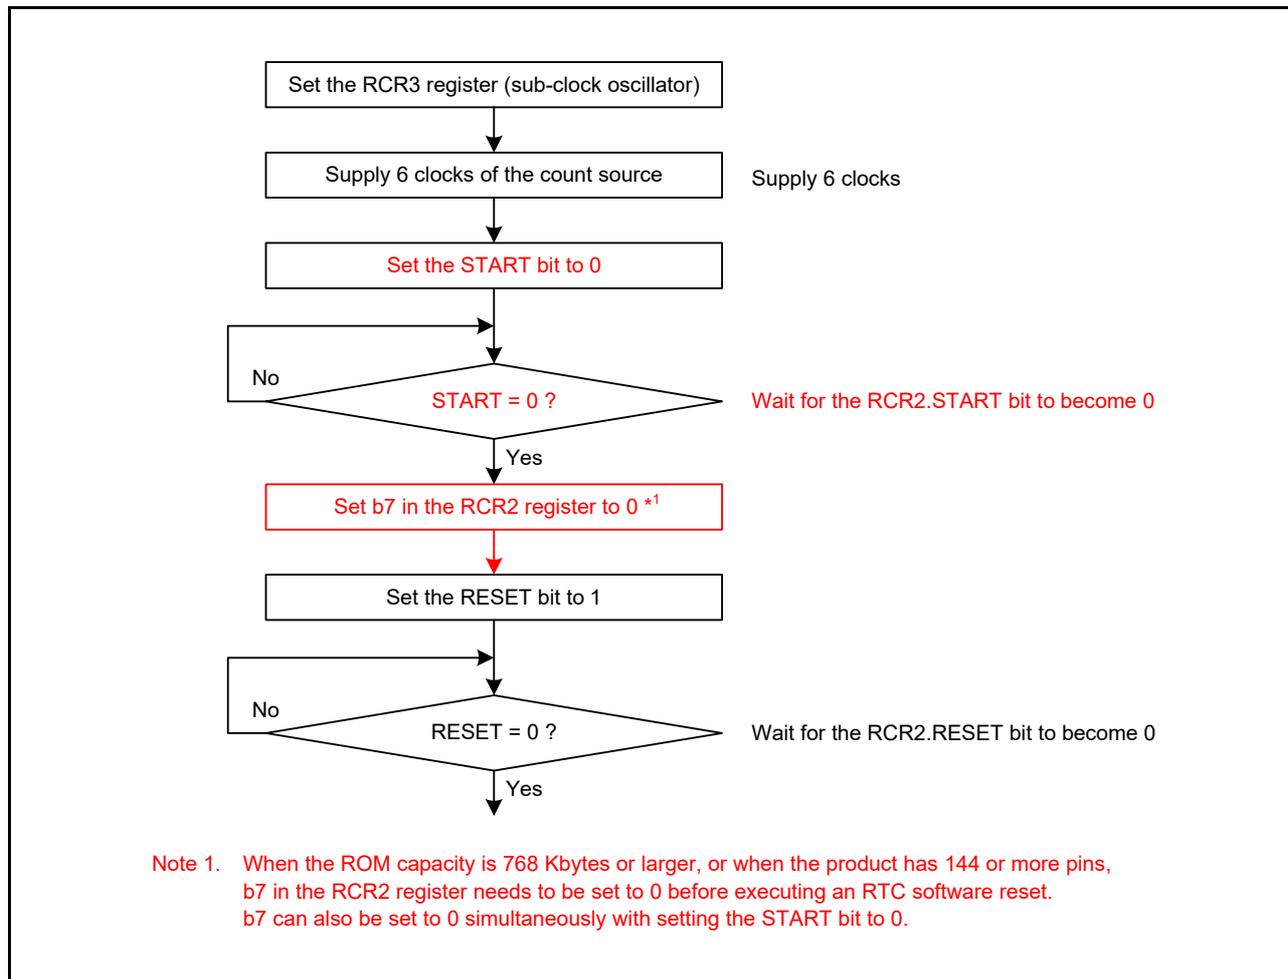
Figure 26.3 Clock Setting Procedure

The setting procedure described in Figure 26.3, Clock Setting Procedure is corrected as follows.
