[Notes]

R20TS0679EC0100

Smart Configurator for RH850

Apr. 01, 2021

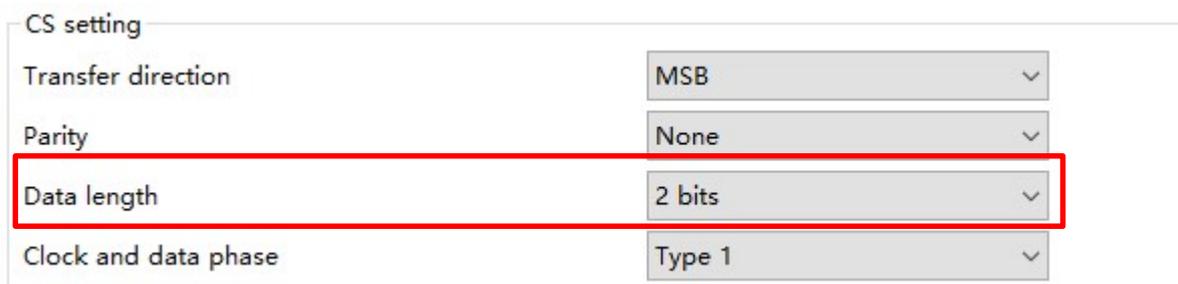
When using CSI master mode and CSI Slave mode on the following peripherals, data transmission occurs error when data length are selected as “2 bits”, “3 bits”, “4 bits”, “5 bits” and “6 bits” on GUI (refer to Figure 1-1 Setting of CSI Master Data length and Figure 1-2 Setting of CSI Slave Data length).

Please don't select data length as "2 bits", "3 bits", "4 bits", "5 bits" and "6 bits" on CSI Master and CSI slave GUI when using CSIG.

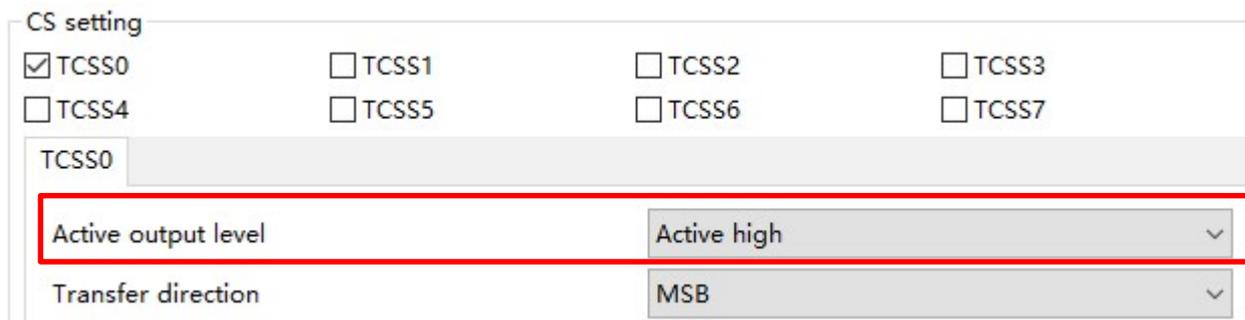
Figure 2-1 Setting of Active output level

When using CSI mater mode on the following peripherals and specifying "High level" as CS active signal (refer to Figure 2-1 Setting of Active output level), the data transmission with slave device failed.

User can manually modify the register setting code in the following source file

CSIH0.CTL0 = _CSIH_OPERATION_CLOCK_STOP;
    .....
    /* Set CSIH0 control setting */
    CSIH0.CTL1 = _CSIH_INTERRUPT_TIMING_NORMAL |
    _CSIH_DATA_CONSISTENCY_CHECK_DISABLE | _CSIH_HANDSHAKE_DISABLE |
    _CSIH_SLAVE_SELECT_DISABLE | _CSIH_CHIPSELECT0_ACTIVE_HIGH;
    .....
}

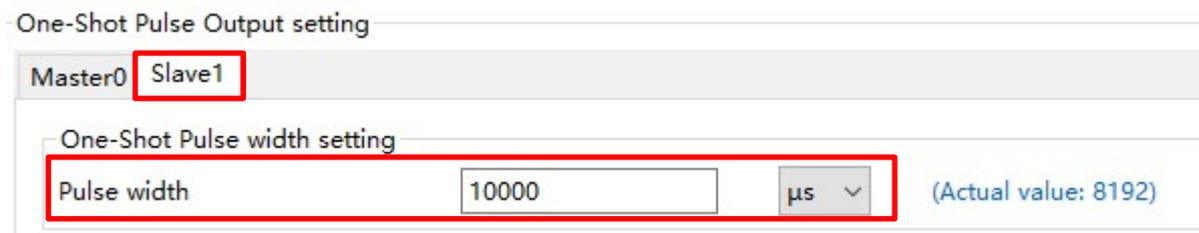
Figure 4-1 Setting of One-shot pulse width

When using One-Pulse Output and One-Shot Pulse Output on the following peripherals, the actual output pulse width has one count clock cycle error due to wrong value is set to timer data register.

Step3: If user find the actual One-shot pulse width output in his own system is not as expected 10000 us, user can increase this macro value by “1”, as the following value in blue.

/*****
Macro definitions
*****/
#define _TAUB0_CHANNEL0_COMPARE_VALUE      (0x270FU)
#define _TAUB0_CHANNEL1_COMPARE_VALUE      (0x2710U)

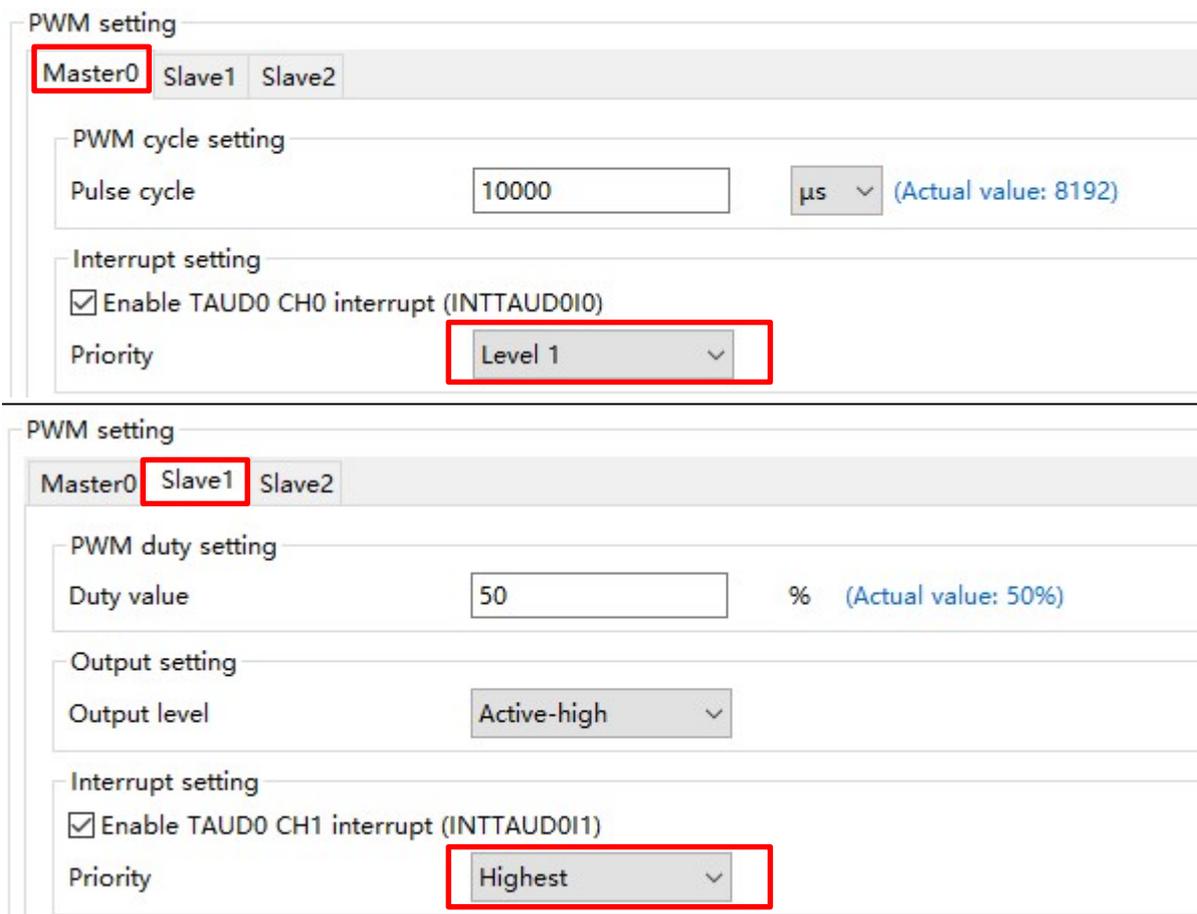
Figure 5-1 Setting of master and slave interrupt priority

When using PWM Output and Triangle PWM Output on the following peripherals, the slave channel interrupt priority is always same as master channel even though user has set different priority level on GUI (refer to Figure 5-1 Setting of master and slave interrupt priority).

User can manually modify the register setting code in the following source file: change the slave channel interrupt priority macro to the priority which is set on GUI. The interrupt priority macro name can be found in “¥smc_gen¥general¥r_cg_macrodriver.h” file.

/* Set INTTAUD0I0 setting */
    INTC1.ICTAUD0I0.BIT.TBTAUD0I0 = _INT_TABLE_VECTOR;
    INTC1.ICTAUD0I0.UINT16 &= _INT_PRIORITY_LEVEL1;
    /* Set INTTAUD0I1 setting */
    INTC2.ICTAUD0I1.BIT.TBTAUD0I1 = _INT_TABLE_VECTOR;
    INTC2.ICTAUD0I1.UINT16 &= _INT_PRIORITY_HIGHEST;
