CUSTOMER NOTIFICATION

SUD-DT-04-0136

78K0 Series Assembler Package RA78K0 Ver. 3.70 Operating Precautions

Windows (Japanese Version)
HP9000 Series 700 (HP-UX)
SPARCstation Family (SunOS/Solaris)

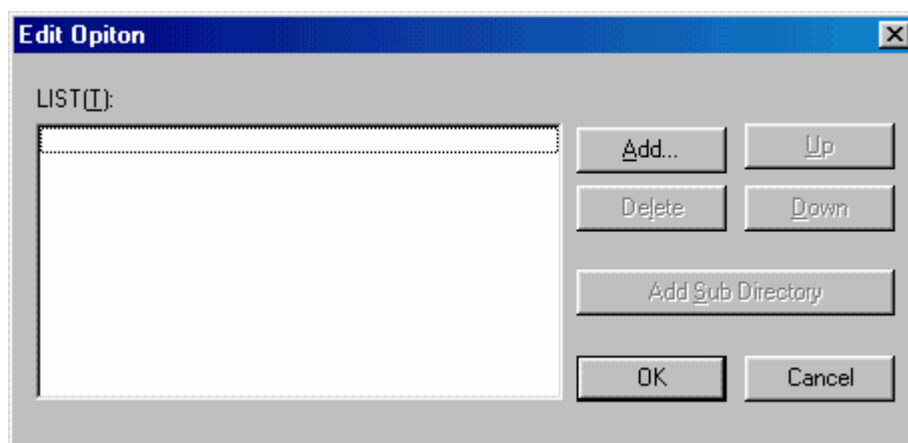
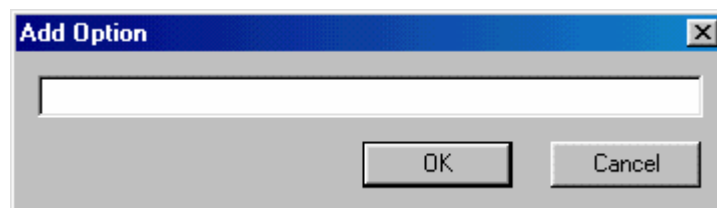
7.2.2 Symbol edit dialog box

Descriptions for when <Edit...> button of the following options is clicked have been added.

- When the <Edit...> button is clicked, the <Edit Option> dialog box appears. The specified symbols can be edited in the list in this dialog box.
- When the <Add...> button is clicked, the <Add Option> dialog box appears and symbols to be added can be edited. If there was already a defined symbol in the list, the new symbol is added at the top of the list.
- When the <Delete> button is clicked, the selected symbol is deleted from the list.
- When the <Up> or <Down> button is clicked, the selected symbol is moved up or down in the list.
- When the <OK> button is clicked, the list editing contents are reflected to the combo box.
- When the <Cancel> button is clicked, the list editing contents are not reflected to the combo box.
